PUBLIC ROADS

APRIL 1939

Page
Experimental Bituminous-Treated Surfaces on Sand-Clay and Marl Bases	21

A BITUMINOUS TREATED EXPERIMENTAL ROAD was built in Berkeley County, South Carolina, in 1929 by the State highway department and the Bureau of Public Roads to obtain information on sand-clay and marl as base materials and on the comparative value of various bituminous materials and methods of construction. This experimental road is still in service and a considerable portion of it is in good condition at the present time. It has been maintained with only such changes as have been brought about by the application of necessary re-treatments and maintenance that have been required to keep it in reasonably good condition at all times. The record of its construction, maintenance, and service behavior, provides an opportunity for the study of a number of factors upon which information was desired.

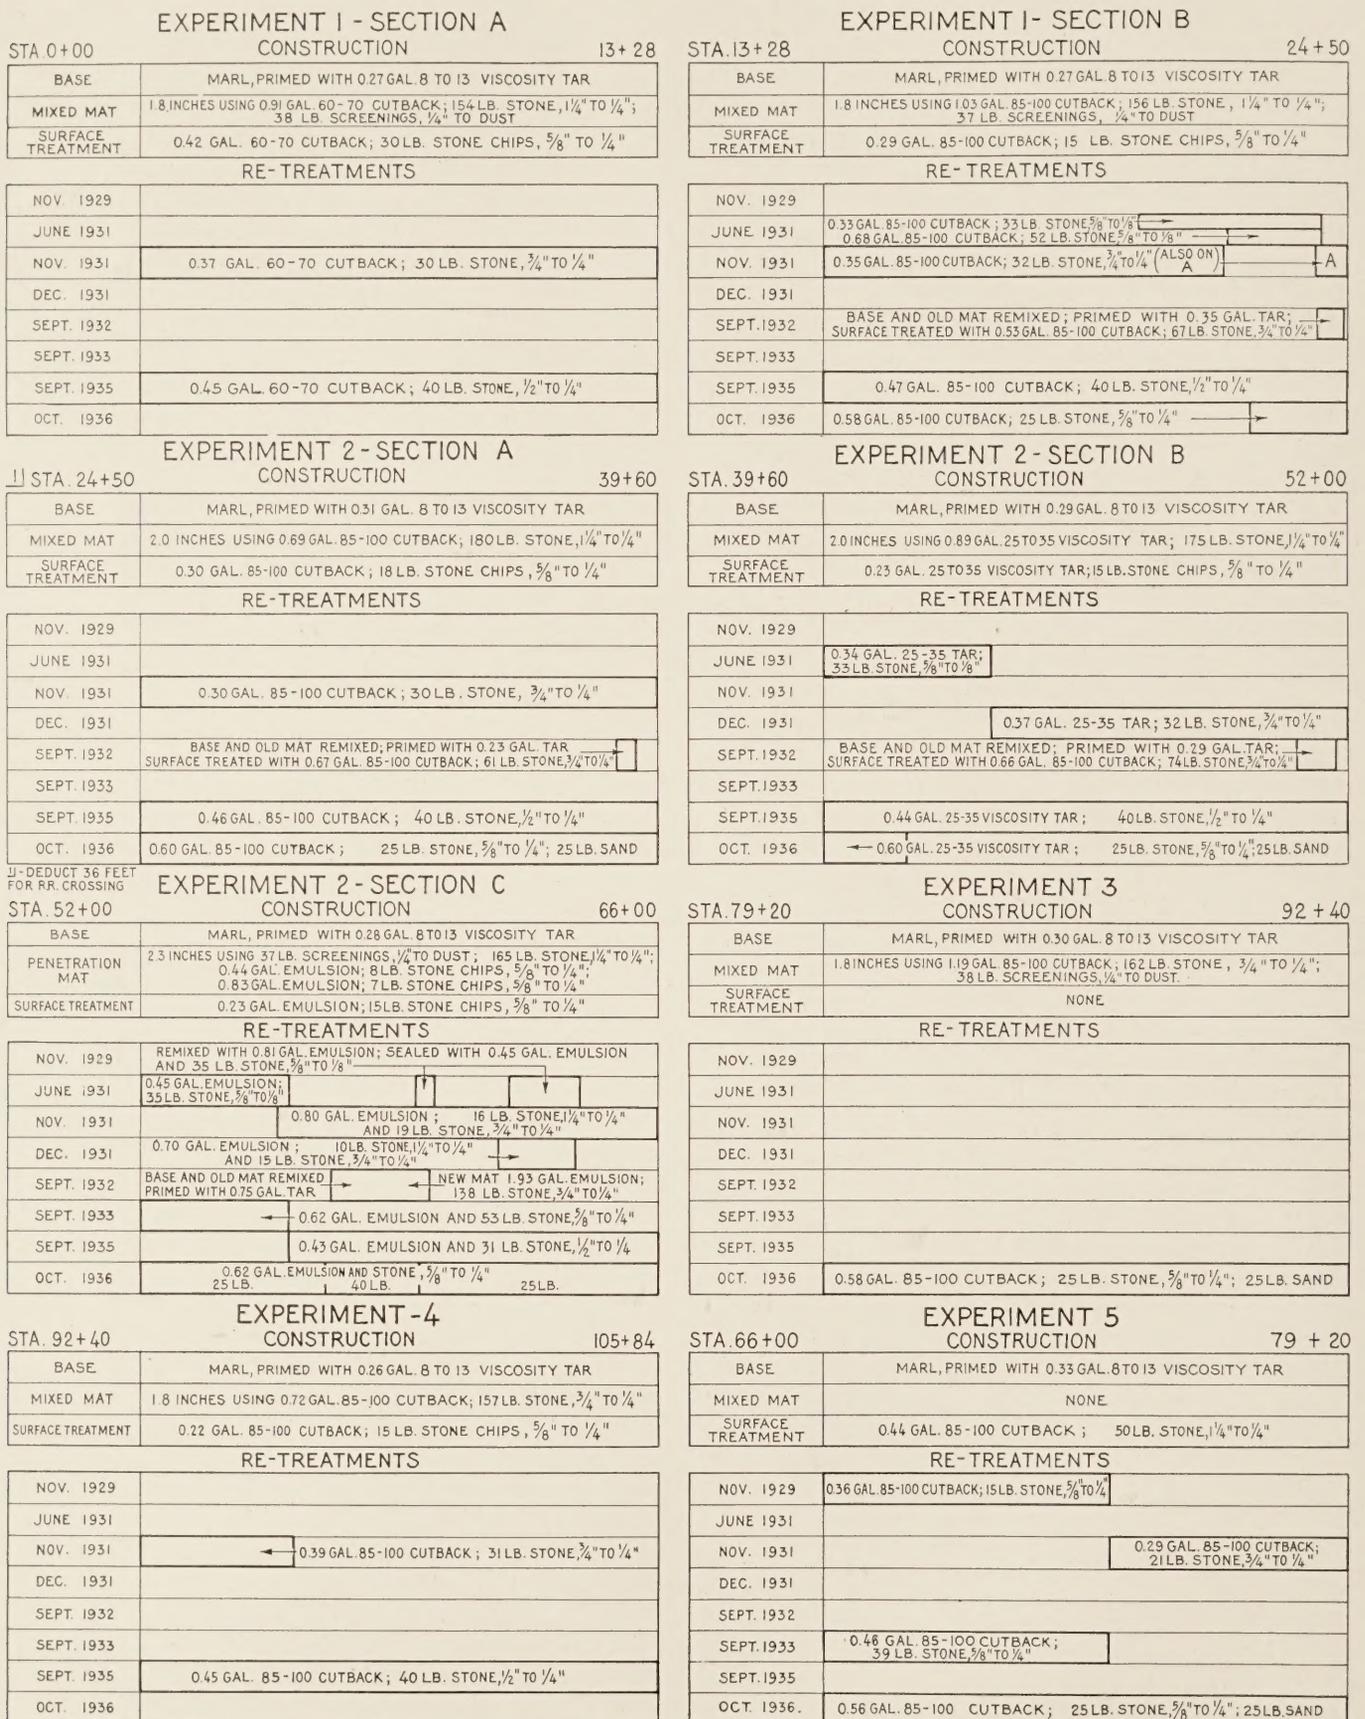
FIGURE 1.—CHARACTER OF CONSTRUCTION AND RE-TREATMENTS APPLIED TO EXPERIMENTS 1 TO 5, INCLUSIVE. QUANTITIES SHOWN ARE AMOUNTS PER SQUARE YARD OF SURFACE AREA.

Figure 1 shows that the section, excepting the west portion, has received only two re-treatments, and the west portion has been re-treated four times and virtually reconstructed twice. When inspected in October 1936, the section, with the exception of the west 200 feet, closely resembled section A in appearance and condition. The west 200 feet were badly cracked as a result of the moisture conditions already described. This part of the section was re-treated later in October. By March 1937, cracks had reappeared on this area and by July the west 50 feet were badly cracked and the marl base was exposed in places.

As shown in figure 1 and by the cost data in table 6, this section required a greater amount of maintenance than any other section and was the least satisfactory. The section lies partly in cut and partly on the highest fill on the experimental road. Trouble with moisture and failure of the marl base were experienced on this section almost from the start. First evidences of failure were surface cracks and sponginess in the base, especially near the center of the section and toward the west end where the section lies on a fill.

Figure 1 shows that the entire section received three re-treatments in addition to the major surface and base repairs required on the central portion and on an area toward the west end.

Figure 1 and table 6 show this experiment to have been the best and the most economical to maintain, of the sections constructed on the marl base. Prior to the re-treatment in 1936 the total accumulated maintenance cost had been only 3 cents per square yard. The mat on this section, while appearing dry most of the time, remained in excellent condition up to the spring of 1936. The surface stayed smooth and unbroken. The mat remained dense and hard. No raveling occurred although a few cracks appeared, some of which closed in warm weather and the remainder of which were sealed with bituminous material.

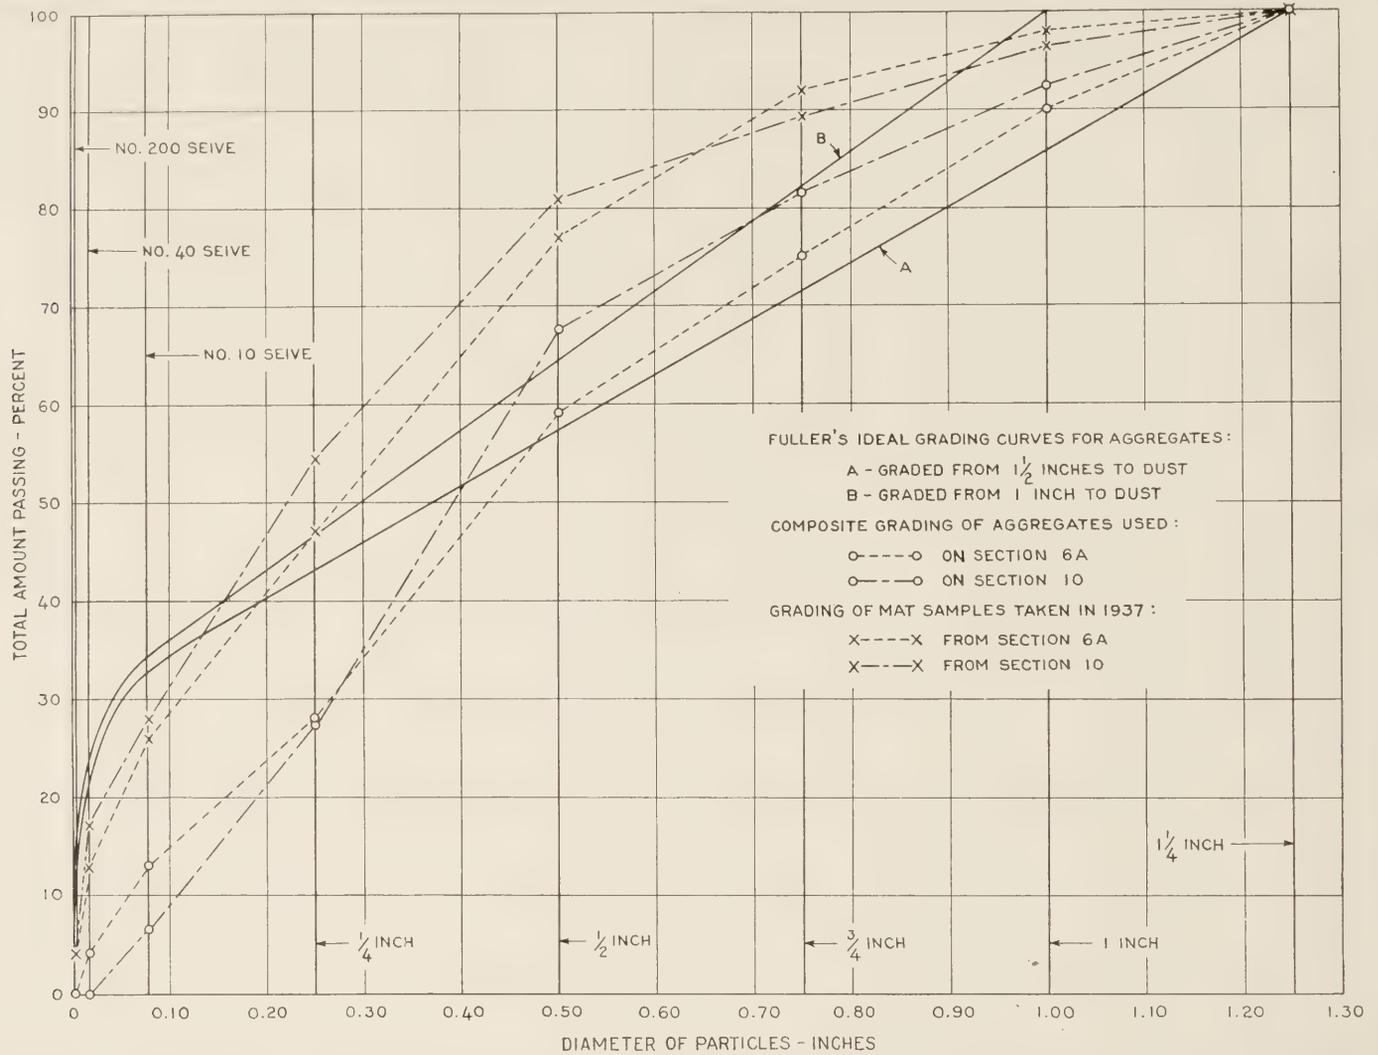
FIGURE 11.—COMPARISON OF ORIGINAL AND FINAL GRADINGS OF AGGREGATES USED IN EXPERIMENTS 6A AND 10 WITH FULLER'S IDEAL CURVE FOR MAXIMUM PRACTICAL DENSITY.

The final grading of the aggregate as determined by an extraction test on a sample taken from experiment 6A in 1937 is shown in figure 11. As will be noted, the percentage passing any given sieve has greatly increased indicating that a considerable amount of crushing has occurred. Since practically all of the extracted aggregate passed the 1-inch sieve, Fuller's curve B, for 1-inch maximum-size aggregate, is more applicable for comparison. Therefore using curve B as a basis for comparison, it will be noted that as a result of the crushing that occurred the final grading has more nearly ap-

proached the maximum density curve especially for the $\frac{1}{4}$ -inch and smaller sizes.

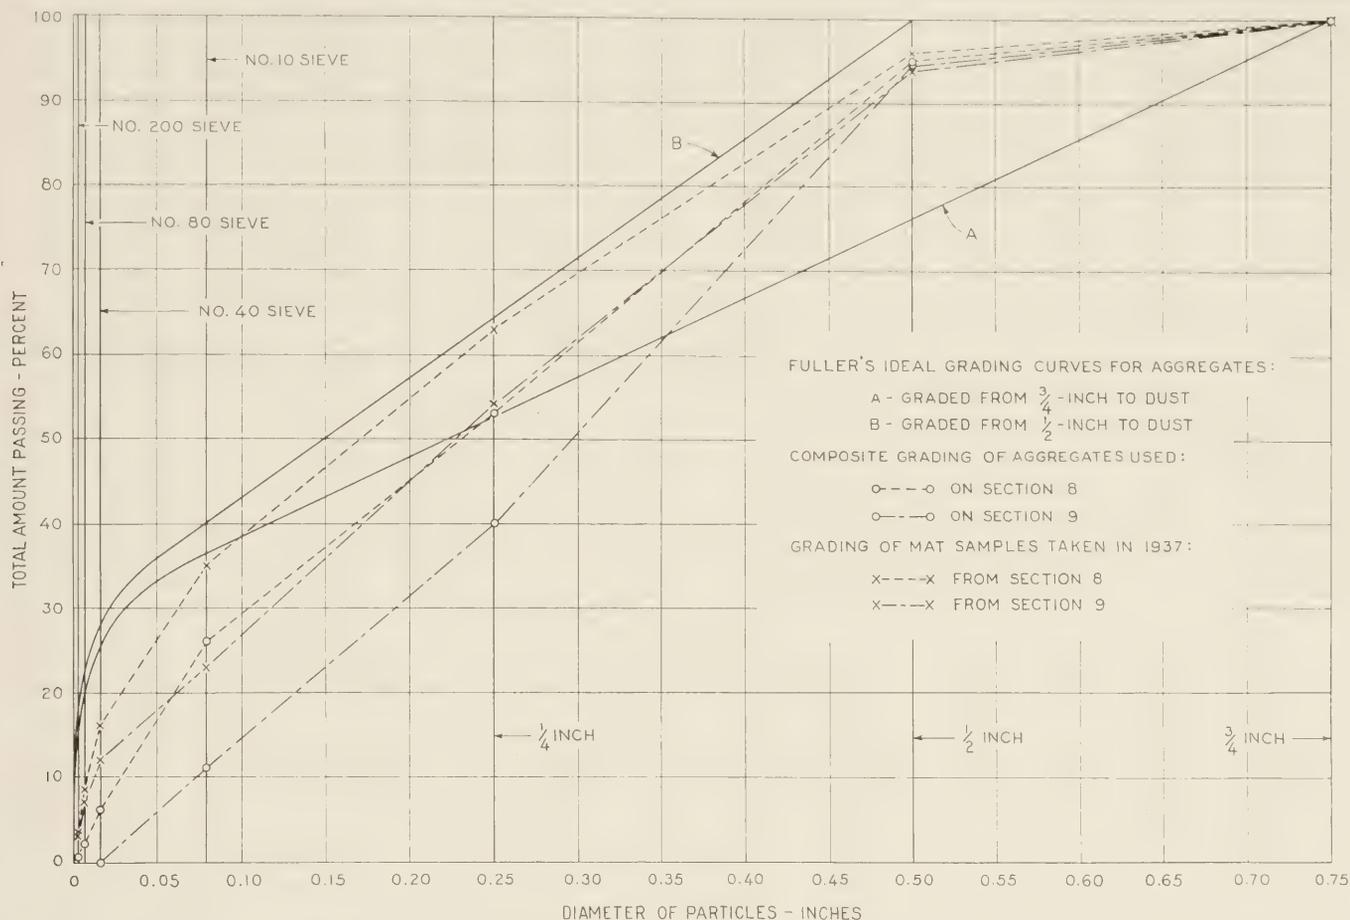
FIGURE 12.—COMPARISON OF ORIGINAL AND FINAL GRADING OF AGGREGATES USED IN EXPERIMENTS 8 AND 9 WITH FULLER'S IDEAL CURVE FOR MAXIMUM PRACTICAL DENSITY.

On experiments 3 and 8, where approximately 20 percent of the finer material was used with $\frac{3}{4}$ - to $\frac{1}{4}$ -inch stone, the mixture was not harsh and the resulting mat seemed sufficiently dense as not to require a seal. It appeared that the amount of finer material used with the smaller-sized coarse stone was much more nearly correct than that used with the $1\frac{1}{4}$ - to $\frac{1}{4}$ -inch stone and the grading curves in figure 12 verify this.
